### **Advisory Visit**

**River Wensum, Bintry Mill (Goff's Beat), Norfolk**

**June 2025**

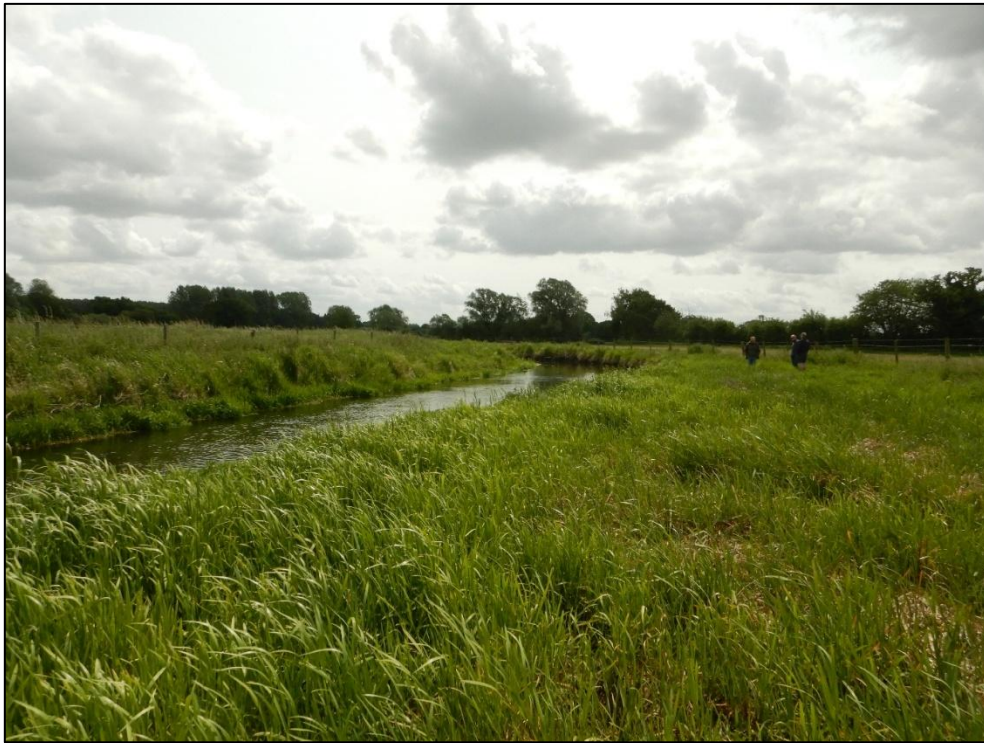
The visit commenced at the upstream end of Goff's Beat (pic 1) where the channel exhibited a wetted width of ~5m but it was clear that marginal vegetation had considerably narrowed the channel from an apparent former width ~12m. The depth could only be estimated from some distance back from the water, it was considered >1.2m.

Pic 1 – The Wensum at the start of the Goff's beat, extensive channel narrowing through marginal encroachment has taken place from the right bank.

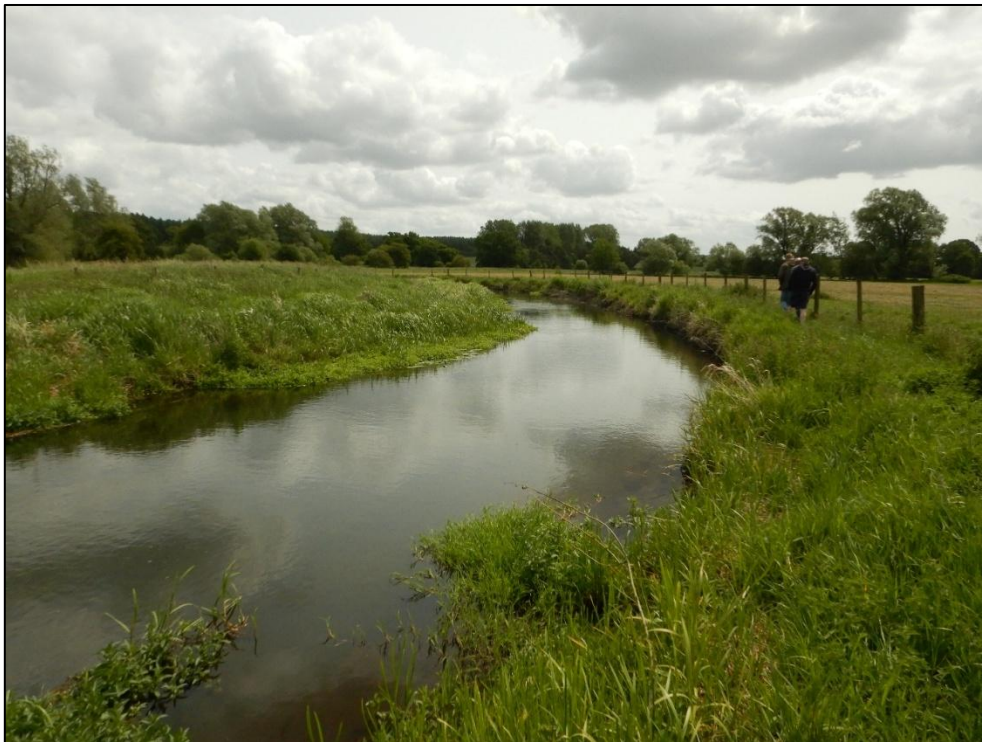
Progressing downstream it became apparent that the river was lacking riparian trees, had little in the way of flow diversity and contained deep areas of dark silt (pic 2). The lack of trees, and the shade they would provide, allows the water to be warmed by sunlight. As the effects of climate change become more pronounced this issue will increase in magnitude. Dark silt also warms quicker than bright clean gravel. Trout require cool water and so may actively avoid areas of water prone to warming.

Pic 2 – The Wensum is open to sunlight with no trees to shade it.

The river was generally sparse in riparian tree cover. BMTF have commenced tree planting, and more should be undertaken.

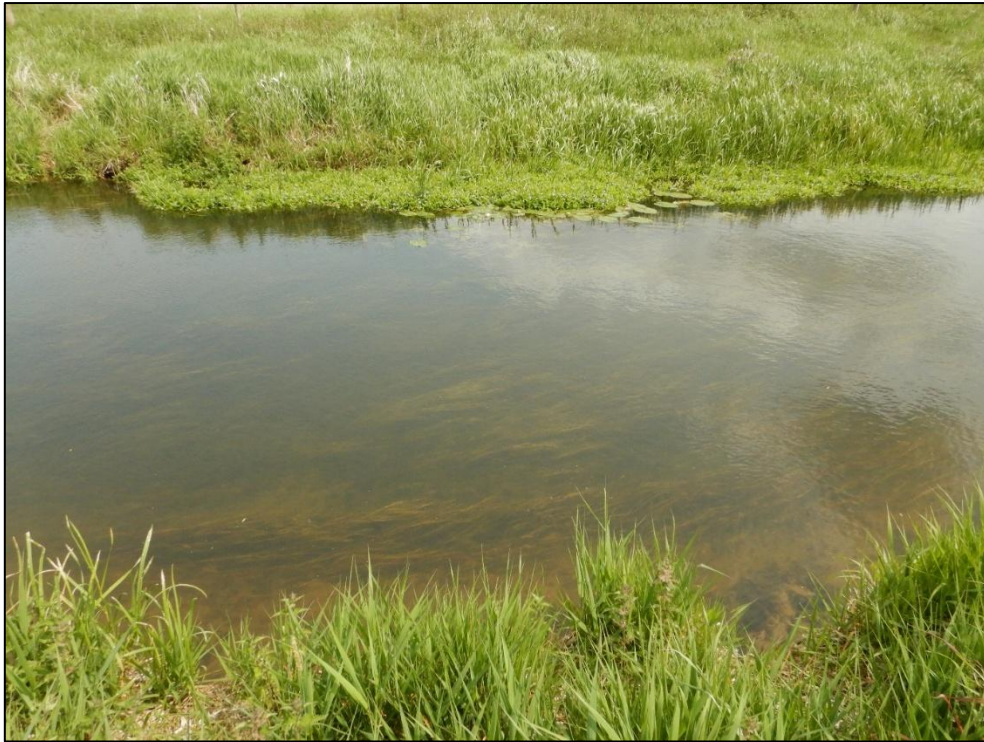
Aquatic plants observed in the Wensum included unbranched burr reed, curled pond weed, yellow water lily, lesser water parsnip and starwort (the last two plants being chalk stream indicator species) (pic 3). Water crowfoot was not seen in Goff's beat. This is quite concerning given the Wensum is designated due to its value as a lowland chalk stream. Water crowfoot is important for providing cover, for holding back flow and channelling it between stands of the plants, and for collecting fine sediment at its roots. It also provides a shade as its fronds float to the surface. The presence of >7 swans and the grazing on plants is likely to have contributed to its apparent loss, but a combination of factors including the lack of flow, nutrient enrichment and high sediment inputs will have affected its growth. It was seen growing in rapid water near to Bintry Mill, but it was still heavily browsed. More information on the plant can be found at [Ranunculus Rivers Leaflet](#).

Pic 3 – The Wensum lacked the high plant diversity that is normally present in chalk streams.

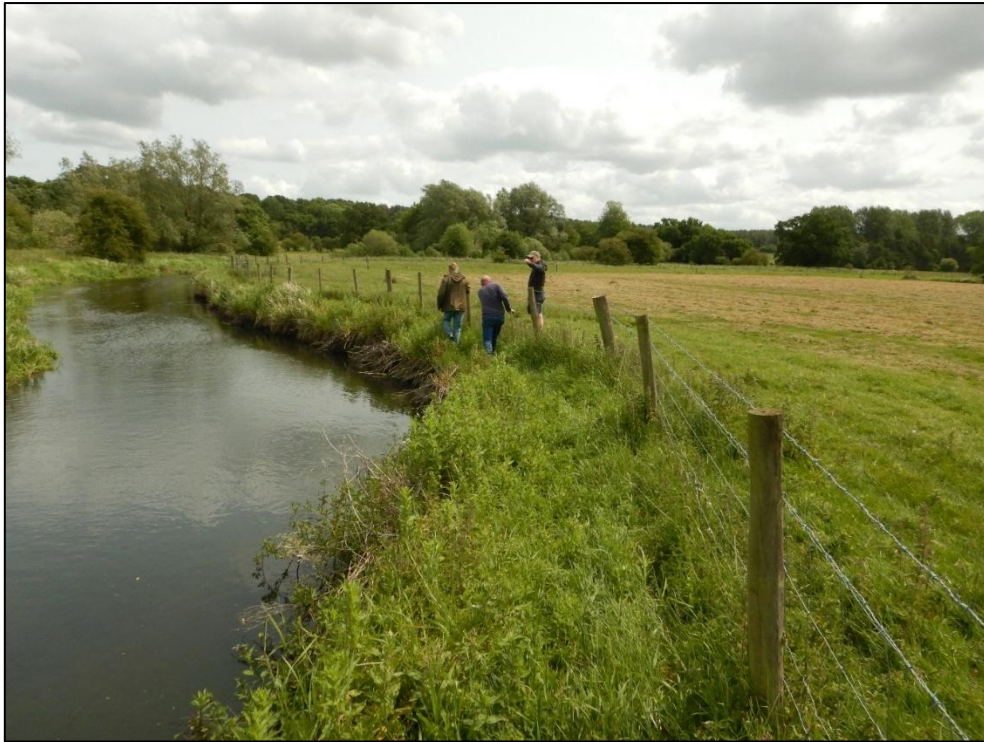
The fence line has recently been re-established to protect the river from grazing. Unfortunately, the fence is very close to the top-of-bank (pic 4), and bank failure is likely to result in the fence being compromised. Ideally, the fence should have been set-back at least 5m to allow a wide naturally vegetated fringe to evolve which could have:

Pic 4 – The fence has been set too close to the river.

- 1) Allowed cover for aquatic invertebrates emerging from the river.
- 2) Allowed the grasses and herbs to establish their full depth root structure without interference from mowing of the path.
- 3) Allowed space for tree planting.
- 4) Allowed an access strip in case of future maintenance or enhancement of the river by machinery.

The right bank fence had been erected too close to the river to allow a natural vegetated fringe to evolve. Instead, the narrow width is taken almost by the mown path. Mowing suppresses the root systems of plants preventing them from reaching their full potential whereby they could offer more bank strength (illustration 2).

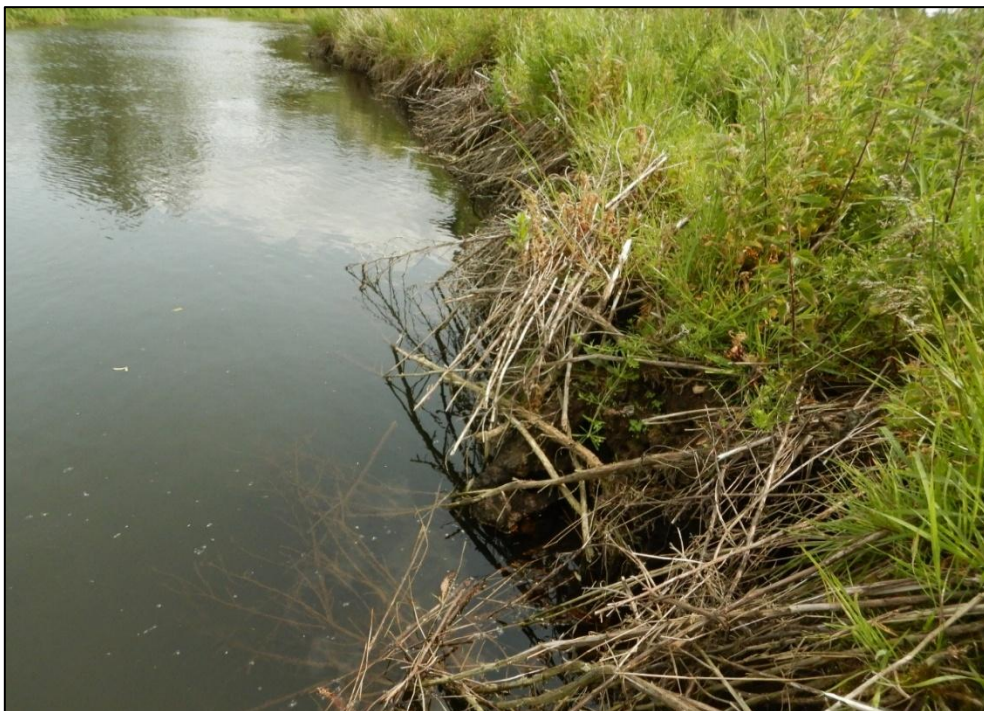
Factors accelerating the bank collapse included extensive burrowing by signal crayfish (an invasive non-native species) and water voles, and recent scouring winter flows. If the bank had been strengthened by trees and deeply rooted grasses, it would hold better. Instead, the bank is collapsing with little root mass to hold it strong (pic 5). The collapse of bank adds more damaging fine sediment to the river.

Pic 5 – The bank is collapsing, adding more fine sediment to the river.

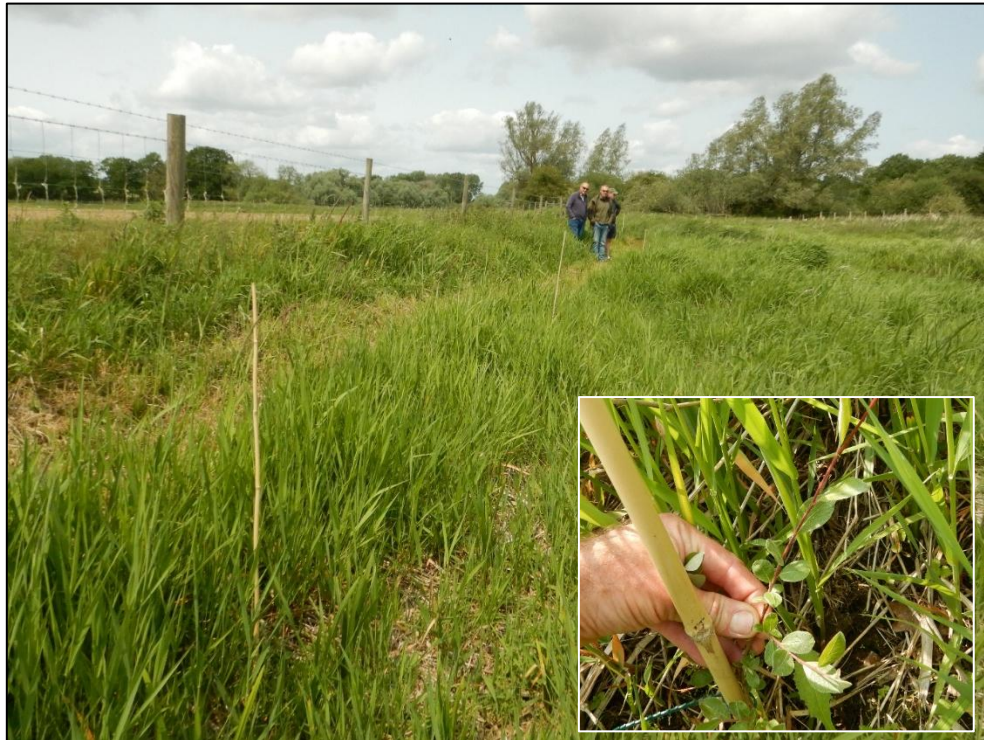
It was very pleasing to see tree planting taking place by BMTF (pic 6), with species obtained from the Woodland Trust including common alder and willow (inset). These trees will provide important cover and bank strength in time (but may need to be protected from water voles).

Pic 6 – BMTF has undertaken riparian tree planting which will bring benefits to the river in time.

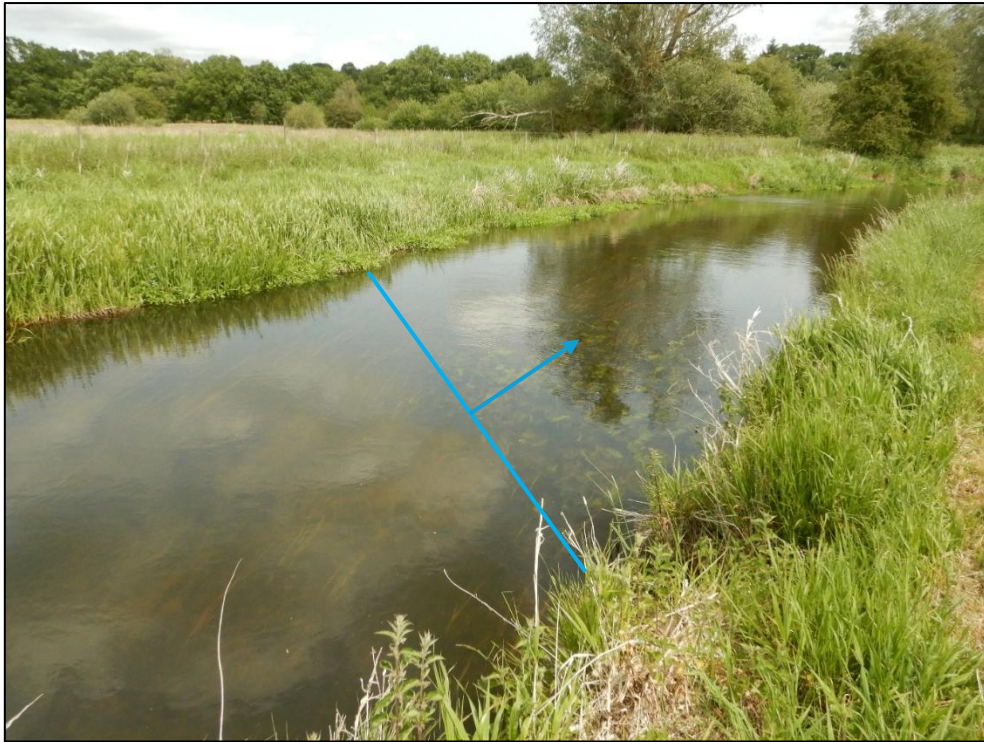
Approximately a quarter down the beat (at 52.75749, 0.953231), the bed lifted as the river turned (pic 7). The shallow depth of the gravel bed resulted in an accelerated flow velocity and diversity, which had cleansed the bed of fine organic silt revealing sand and gravel (pic 8). Most encouragingly, the bed was shallow making it suitable to be further enhanced through the introduction of mixed grade gravel (see recommendations).

Pic 7 – An up-lift in the bed occurred (blue line) presenting an opportunity for habitat enhancement through gravel addition to the “shallow reach”.

One clear location for bed raising/enhancement was observed at 52.757479, 0.953186 through to 52.756509, 0.954969 a length of ~170m. It would be suitable for bed raising and narrowing using mixed grade gravel (pic 18). Placed gravel should not be level, it should taper across the river from just above water level at the right bank, to possibly a depth of 0.3m towards the left bank. A large tapering shoal-like feature will be more adaptable to differing flow heights. As was seen further upstream in the fishery, adding LWM over raised gravel ensures that complex cover is provided (excellent for juvenile trout), that multiple flow pathways are established and that flow diversity is maximised. Potentially, these features could offer trout spawning areas.

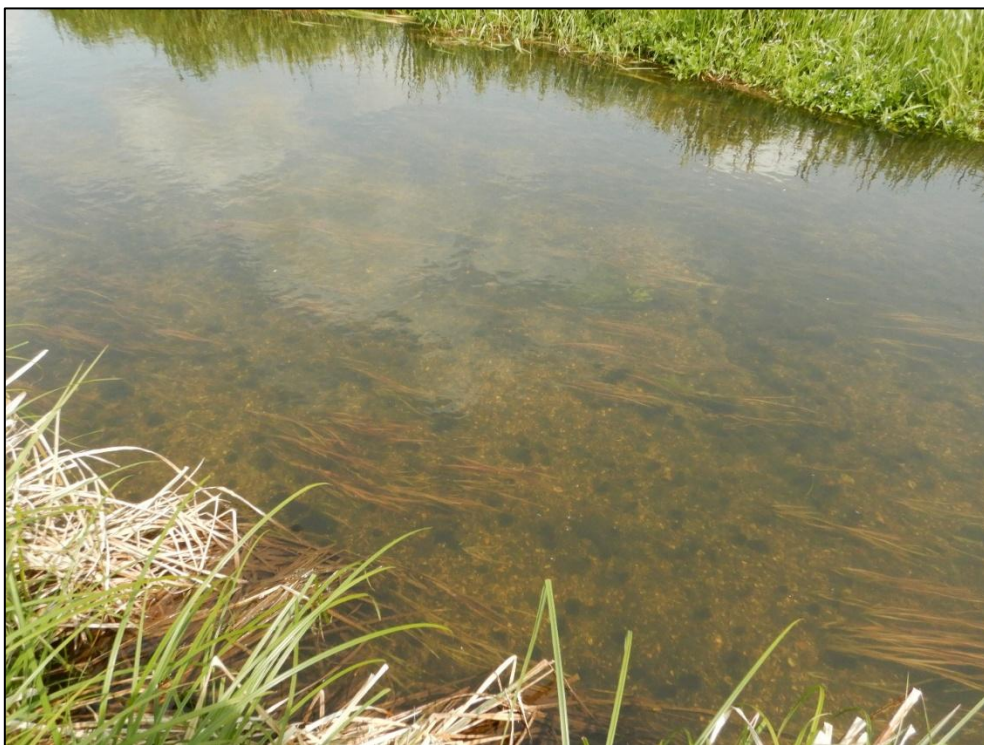
Pic 8 – Where the river ran shallow it revealed sand and gravel, but the substrates were poorly sorted limiting their potential for successful trout spawning.

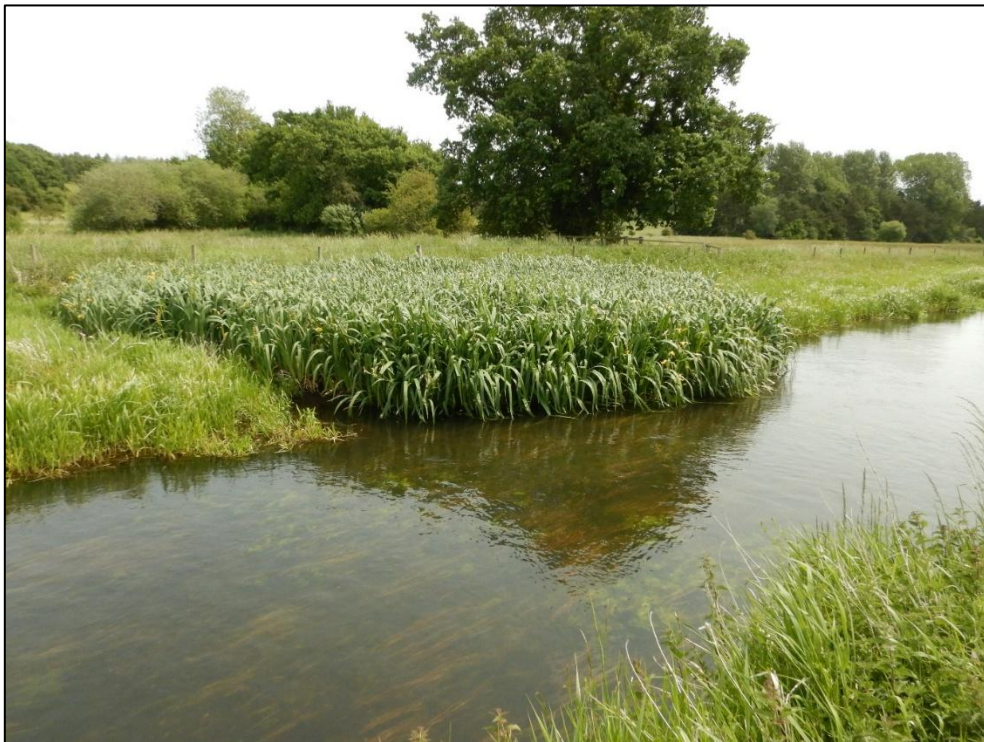
Within the “shallow reach” left bank margin an extensive stand of yellow flag iris was present. The shape of the stand suggests it was once a cattle watering bay. Re-establishing former bays should be considered by BMTF as they provide fish refuge from high flows when the river is in flood, which in turn reduces the risk of fish washout from the beat. Flag iris is also an important cover plant for trout fry. The plants’ rhizomes can become strongly rooted, providing cover like fallen branches, which in turn give shelter from flow for trout fry. The plants could be divided up and replanted throughout the fishery to increase marginal cover.

Pic 9 – A possible former cattle watering bay that has become colonised by yellow flag iris.

A very significant stand of yellow flag iris was present. It could have some plants removed, divided-up and replanted throughout the fishery, especially where the river runs fast and shallow. The plant provides excellent early season cover when few other plants have emerged (pic 19).

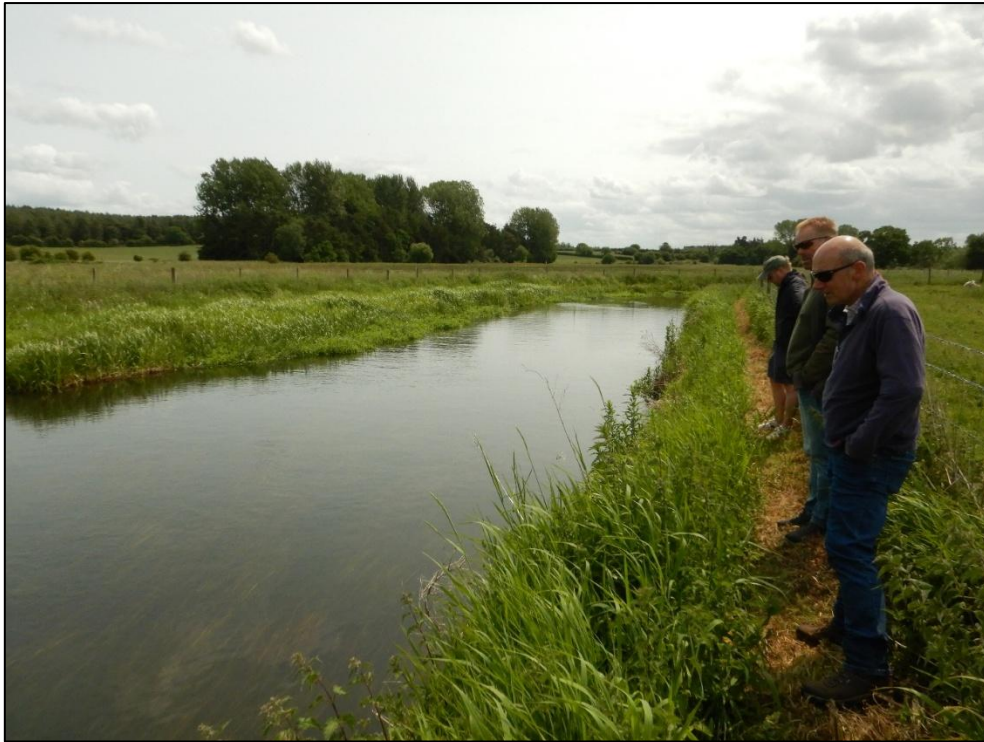
After ~170m the shallow reach ended abruptly (at 52.756509, 0.954969) returning to a depth estimated at ~1m, and returned to a rather featureless river again with little to hold wild brown trout (pic 10). NB post visit thought, is this actually an area of previous bed raising that wasn't known when on site?

Pic 10 – Much of Goff's beat had little to hold wild brown trout.

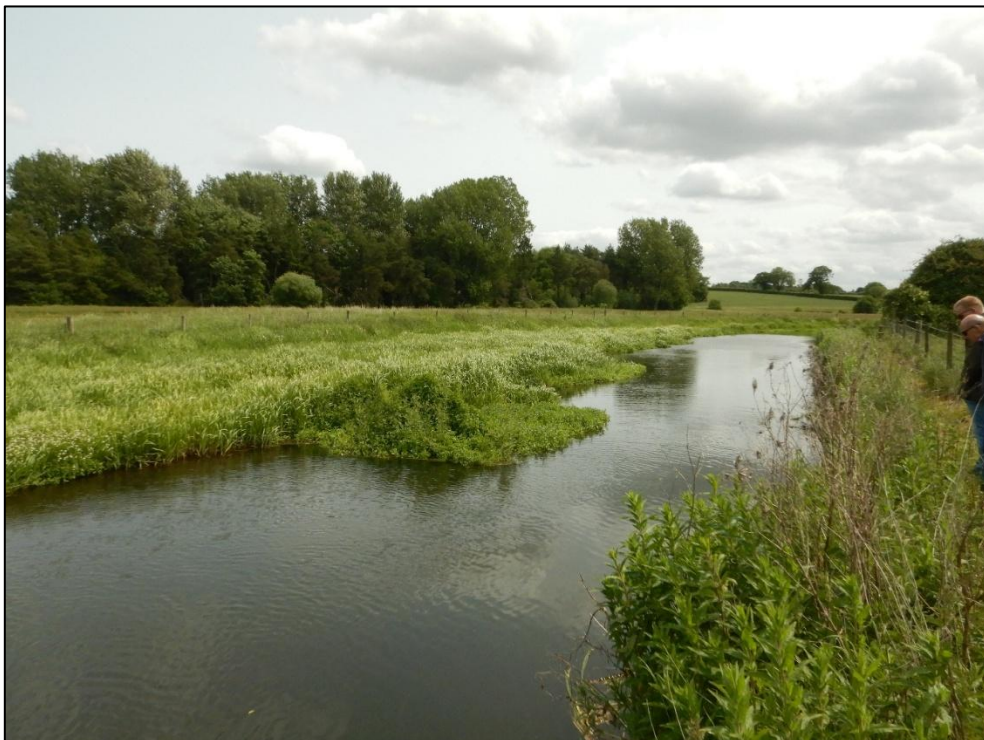
Moving downstream ~100m a small willow on the left bank illustrated its value; it had caught material drifting on the flow resulting in the establishment of weed wrack. This provided important overhead cover (pic 11) in a largely open fishery. If it does not retain a trout, it will attract chub.

Pic 11 – In an otherwise open fishery the occurrence of small willows collects drifting material allowing valuable overhead cover to establish.

With the beat having so few riparian trees, where they do occur and trail to water all branches should be retained for the cover and flow diversity that they bring.

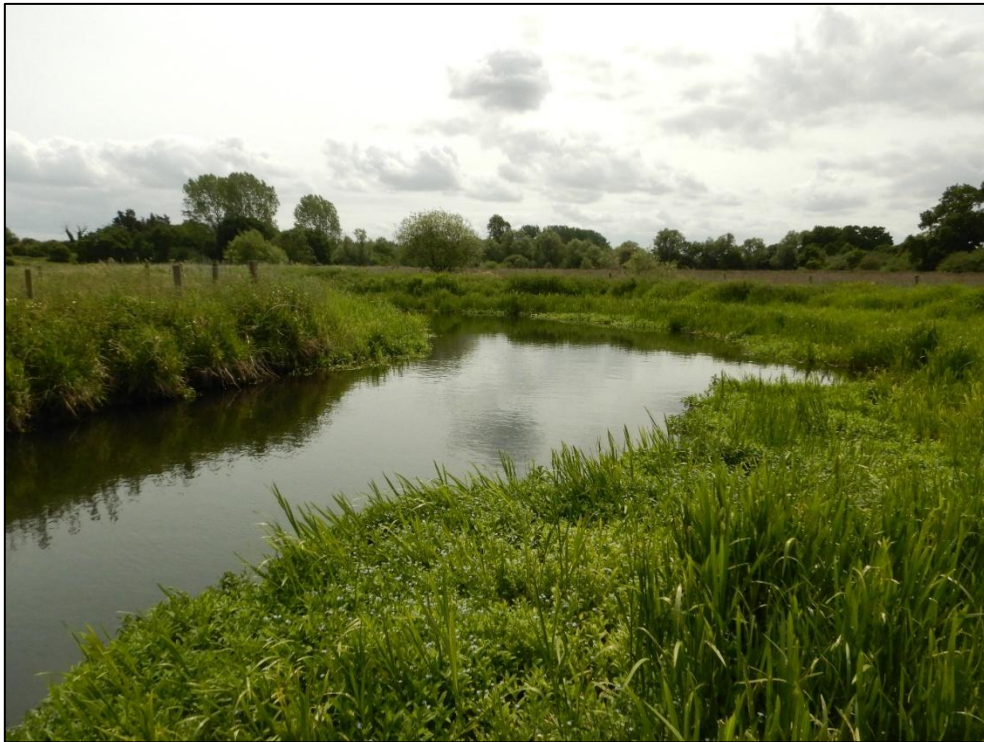
At 52.754353, 0.956439 a series of tight meander loops were observed, although it was reported that the spring drought had caused the river's flow to significantly reduce, the lack of flow diversity through the meanders was surprising. ~2km downstream is the North Elmham mill, it is suspected that the mill is impounding approximately half of Goff's beat. With flow impounded, natural river processes of scour and sediment transport are reduced (or possibly even stopped). Trout require environments that have flow and habitat diversity, impounded reaches are not where one would find naturally diverse and sustainable trout populations. However, the beat should support a mixed fishery with trout present (typically larger adults utilising the deeper water). The ideal situation would be to reduce the head of water retained by the mill. Lessening the impounded flow would most probably increase flow velocity through Goff's beat. However, it is recognised that this could be complex request given the SAC designation afforded to the grazing marshes which require a high water table.

Pic 12 – The glass-like water surface through a series of meanders suggests impounded flow

It is thought that North Elmham mill impounds approximately half of the beat. Any negotiations to reduce the head of water impounded by the mill would improve flow velocity along the beat, which in turn could initiate scour and fine sediment transport, ultimately improving conditions for wild brown trout.

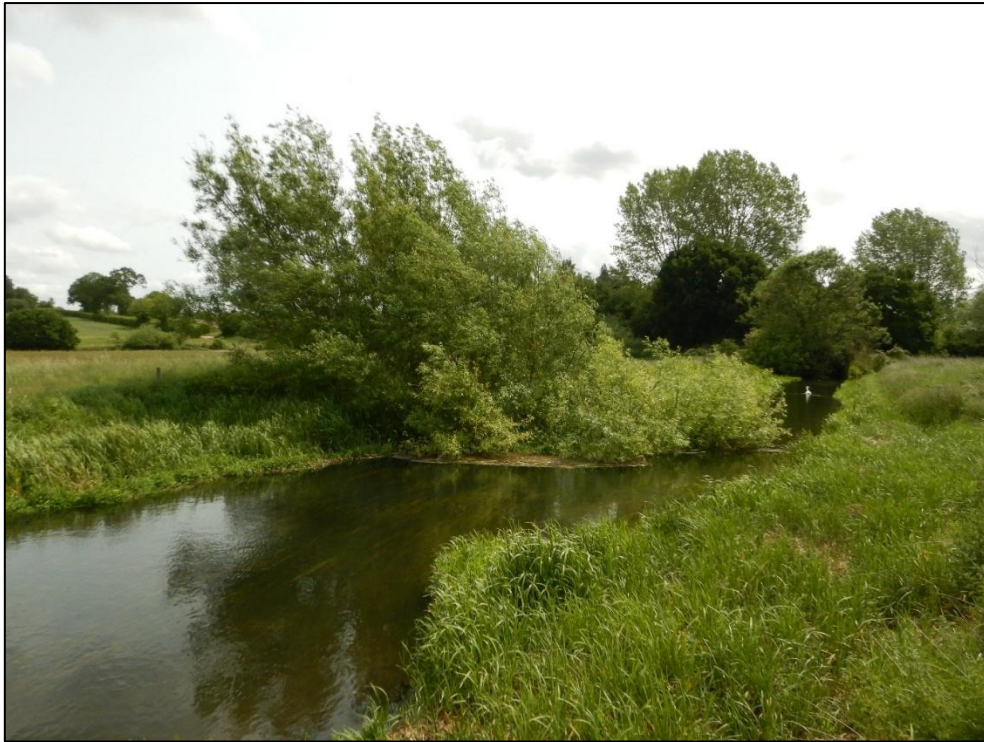
Towards the end of the beat a few mature trees were observed. A large willow trailed to water (pic 13), with an accumulation of material which forced water down against the bed. A small, but important, area of bed scour had been produced illustrating how trees could provide flow diversity to the beat to some extent (but does not negate the belief that the impounding effect of the mill is leading to a range of constraints on the beat).

Pic 13 – Willows trailing to water are an important habitat feature.

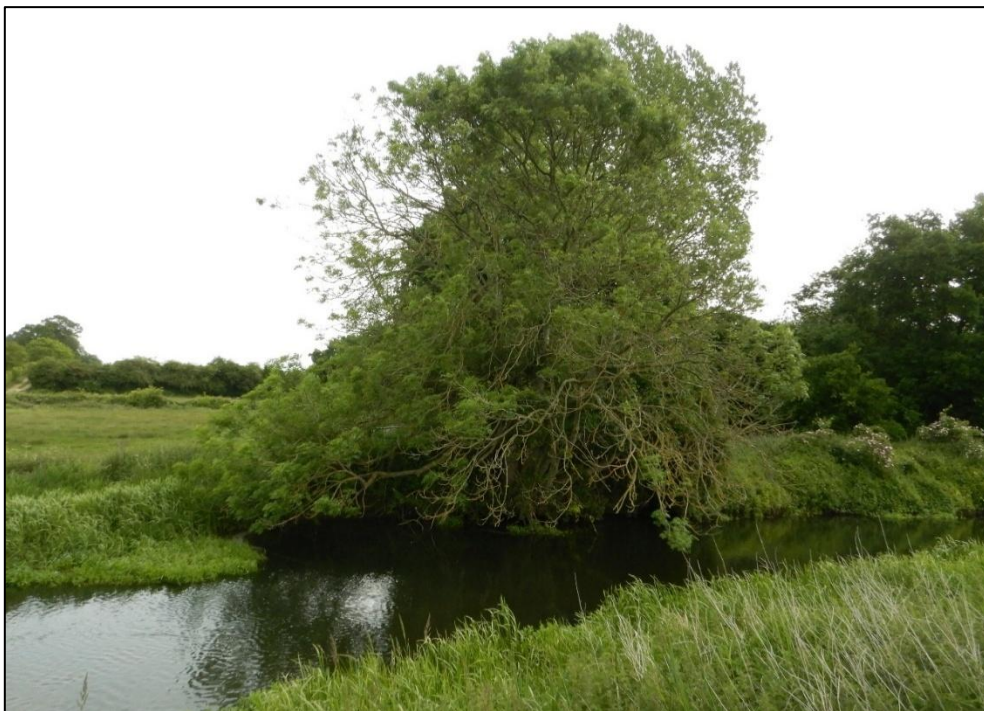
A large ash tree covered the water, shading out aquatic vegetation beneath it, presenting an interesting, and ecologically valuable, contrasting habitat to the more open and weedy areas. It's interesting to note that it was only the left bank that held notable trees. Historic grazing of an unfenced right bank has left a legacy of few trees, it is good that BMTF is already taking steps to establish trees to the right bank.

Pic 14 – An ash tree over the river provides valuable shade.

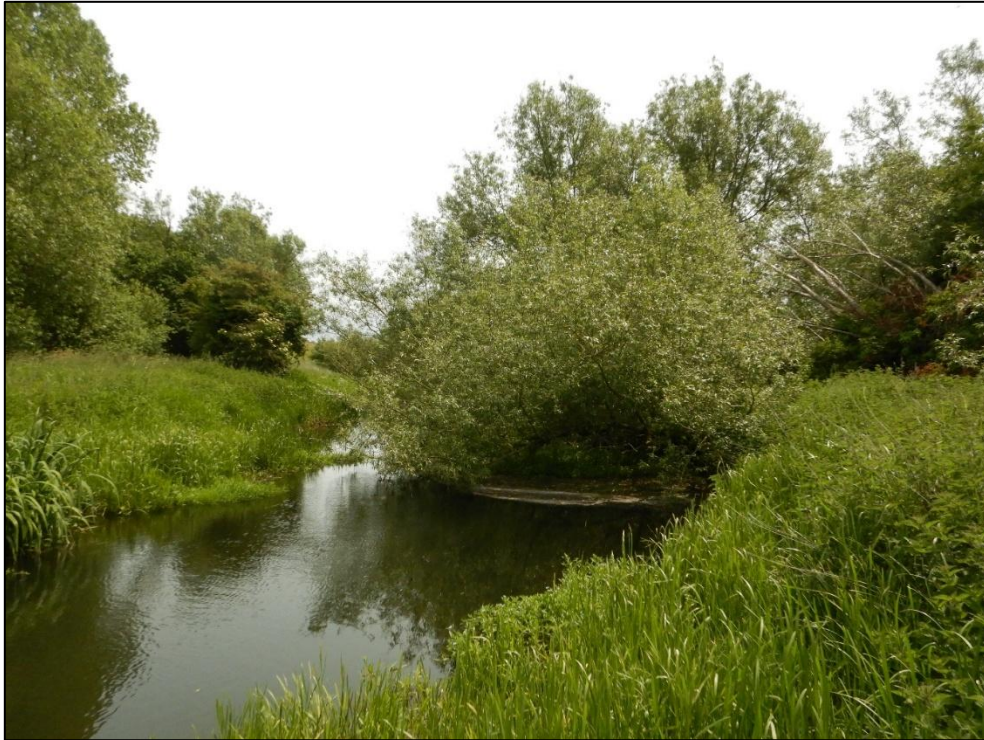
The beat ended as the river flowed into a tree-lined reach, and with more tree cover at water level, the river below Goff's beat is more likely to hold trout than the more open water within the beat.

Pic 15 – Trailing trees downstream of the beat may retain more trout (and other fish species).

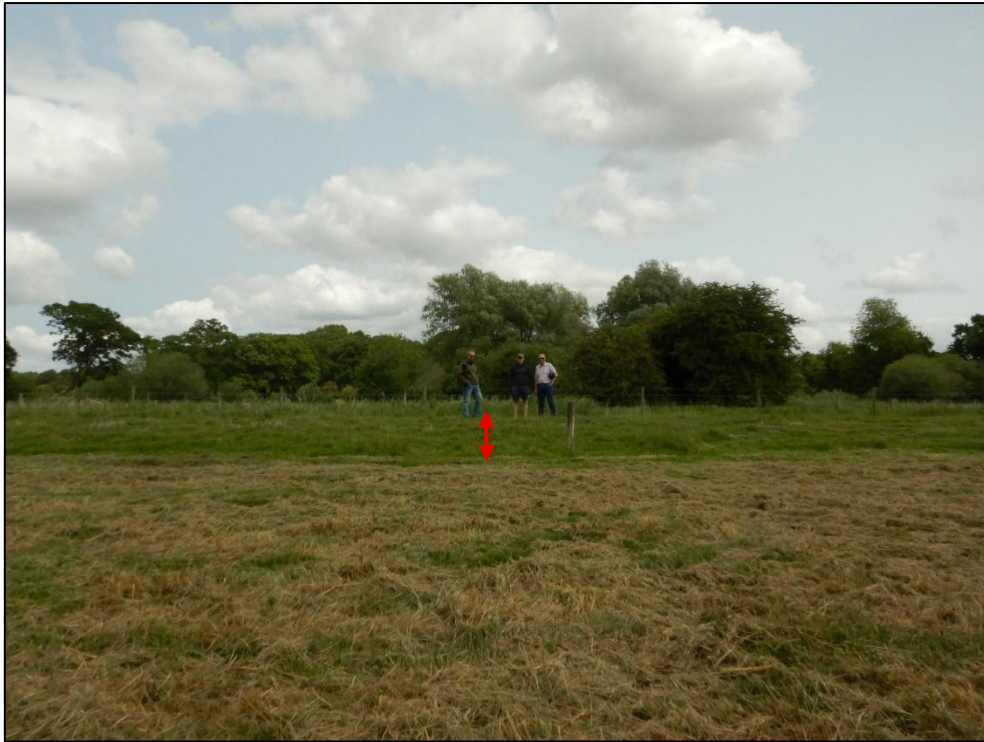
Whilst walking back up the beat attention was drawn to the grazing marsh. It was clearly embanked to a height  $\sim 0.75\text{m}$  (pic 16), probably the legacy of a mill embankment. The embankment was growing coarse vegetation which had not been cut for hay. Removal of the embankment (or breaches to it) would allow the river to connect to its floodplain, presenting the opportunity for fine sediment to be deposited on land. This would help to address one of the issues negatively affecting the river as identified in the 2024 Natural England condition assessment: widespread sedimentation impacts. NB as mentioned previously, any activity that could impact upon the ecological value of the grazing marshes must be first discussed with the landowner and Natural England given the site's SAC status.

Pic 16 – The river is significantly embanked (red arrow), this stops floodplain connection.

The majority of the beat appeared to be embanked on the right bank. The levee was  $\sim 0.75\text{m}$ . It is assumed that the embankment is formed from past river dredgings, thus it may contain a high proportion of coarse sediment (gravels, cobbles and grit). If the levee were removed or breached in multiple places to allow floodplain connection, then the material may be suitable for screening and return to the river to restore its rather uniform bed profile.

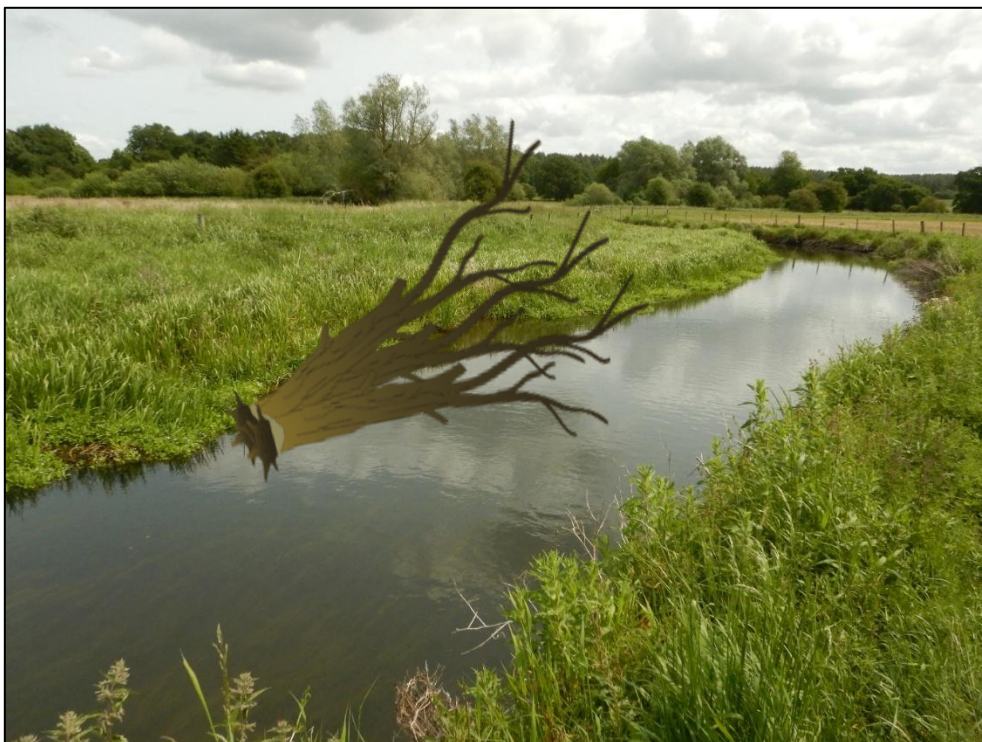
Pic 17 – Introducing tree-tops as LWM would be a valuable habitat enhancement for enhancing flow diversity and increasing cover (such as at 52.757506, 0.952295).

The river lacked flow diversity, partly due to it being depleted of LWM. The river was open and could respond well to whole tree-tops being fixed in margins to create flow deflecting features and areas of complex underwater cover. The beat has much capacity to introduce LWM (pic 17). If placed in an off-set opposing arrangement it might be possible to create a more sinuous channel within the current one.

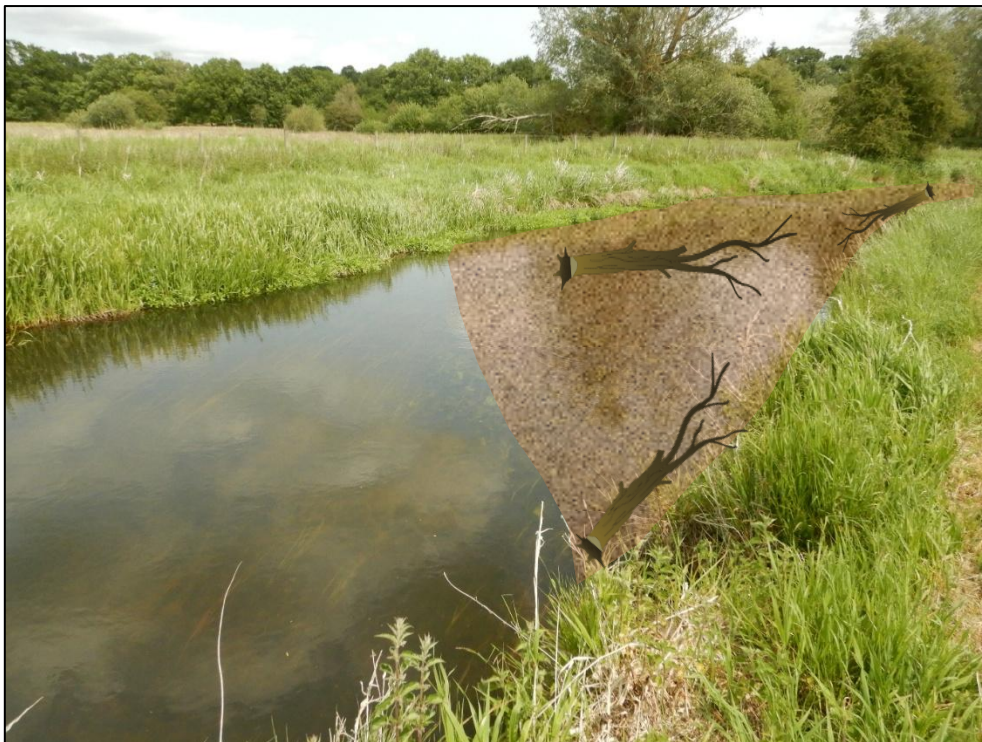
Pic 18 – The “shallow reach” annotated to show how additional further gravel could make a significant improvement to the reach. Adding LWM over the gravel would bring further benefits.

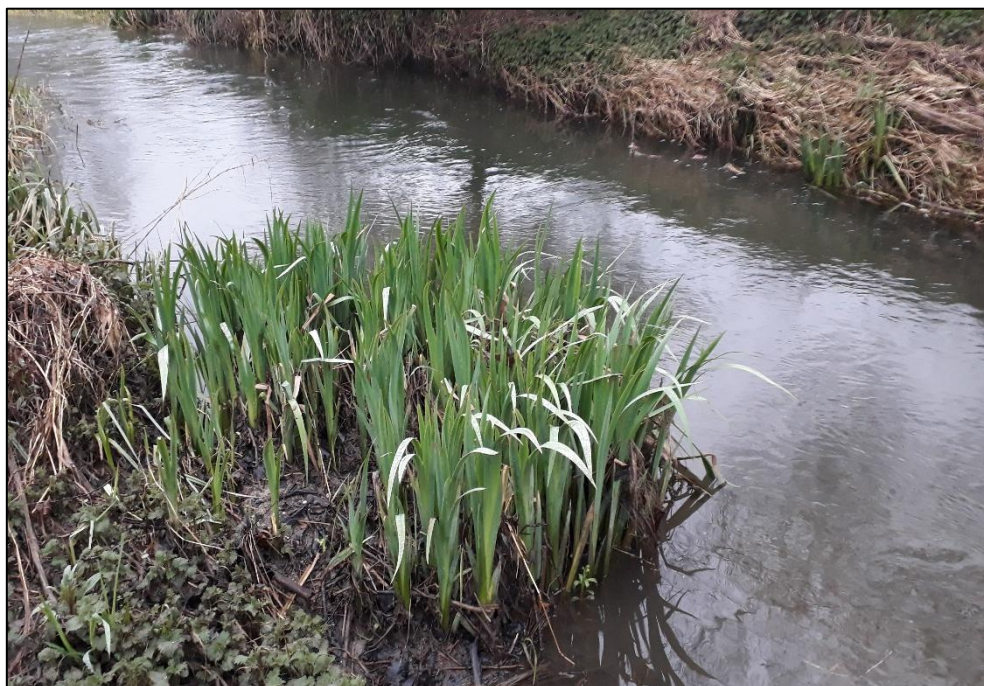
Pic 19 – Yellow flag iris providing cover in late March when few other marginal plants have grown.
